**FINAL OVERVIEW GEOTECHNICAL HAZARD ASSESSMENT REPORT
- ELECTORAL AREA F (HATZIC VALLEY), FRASER VALLEY
REGIONAL DISTRICT**

Electoral Area "F"
Overview Geotechnical Study

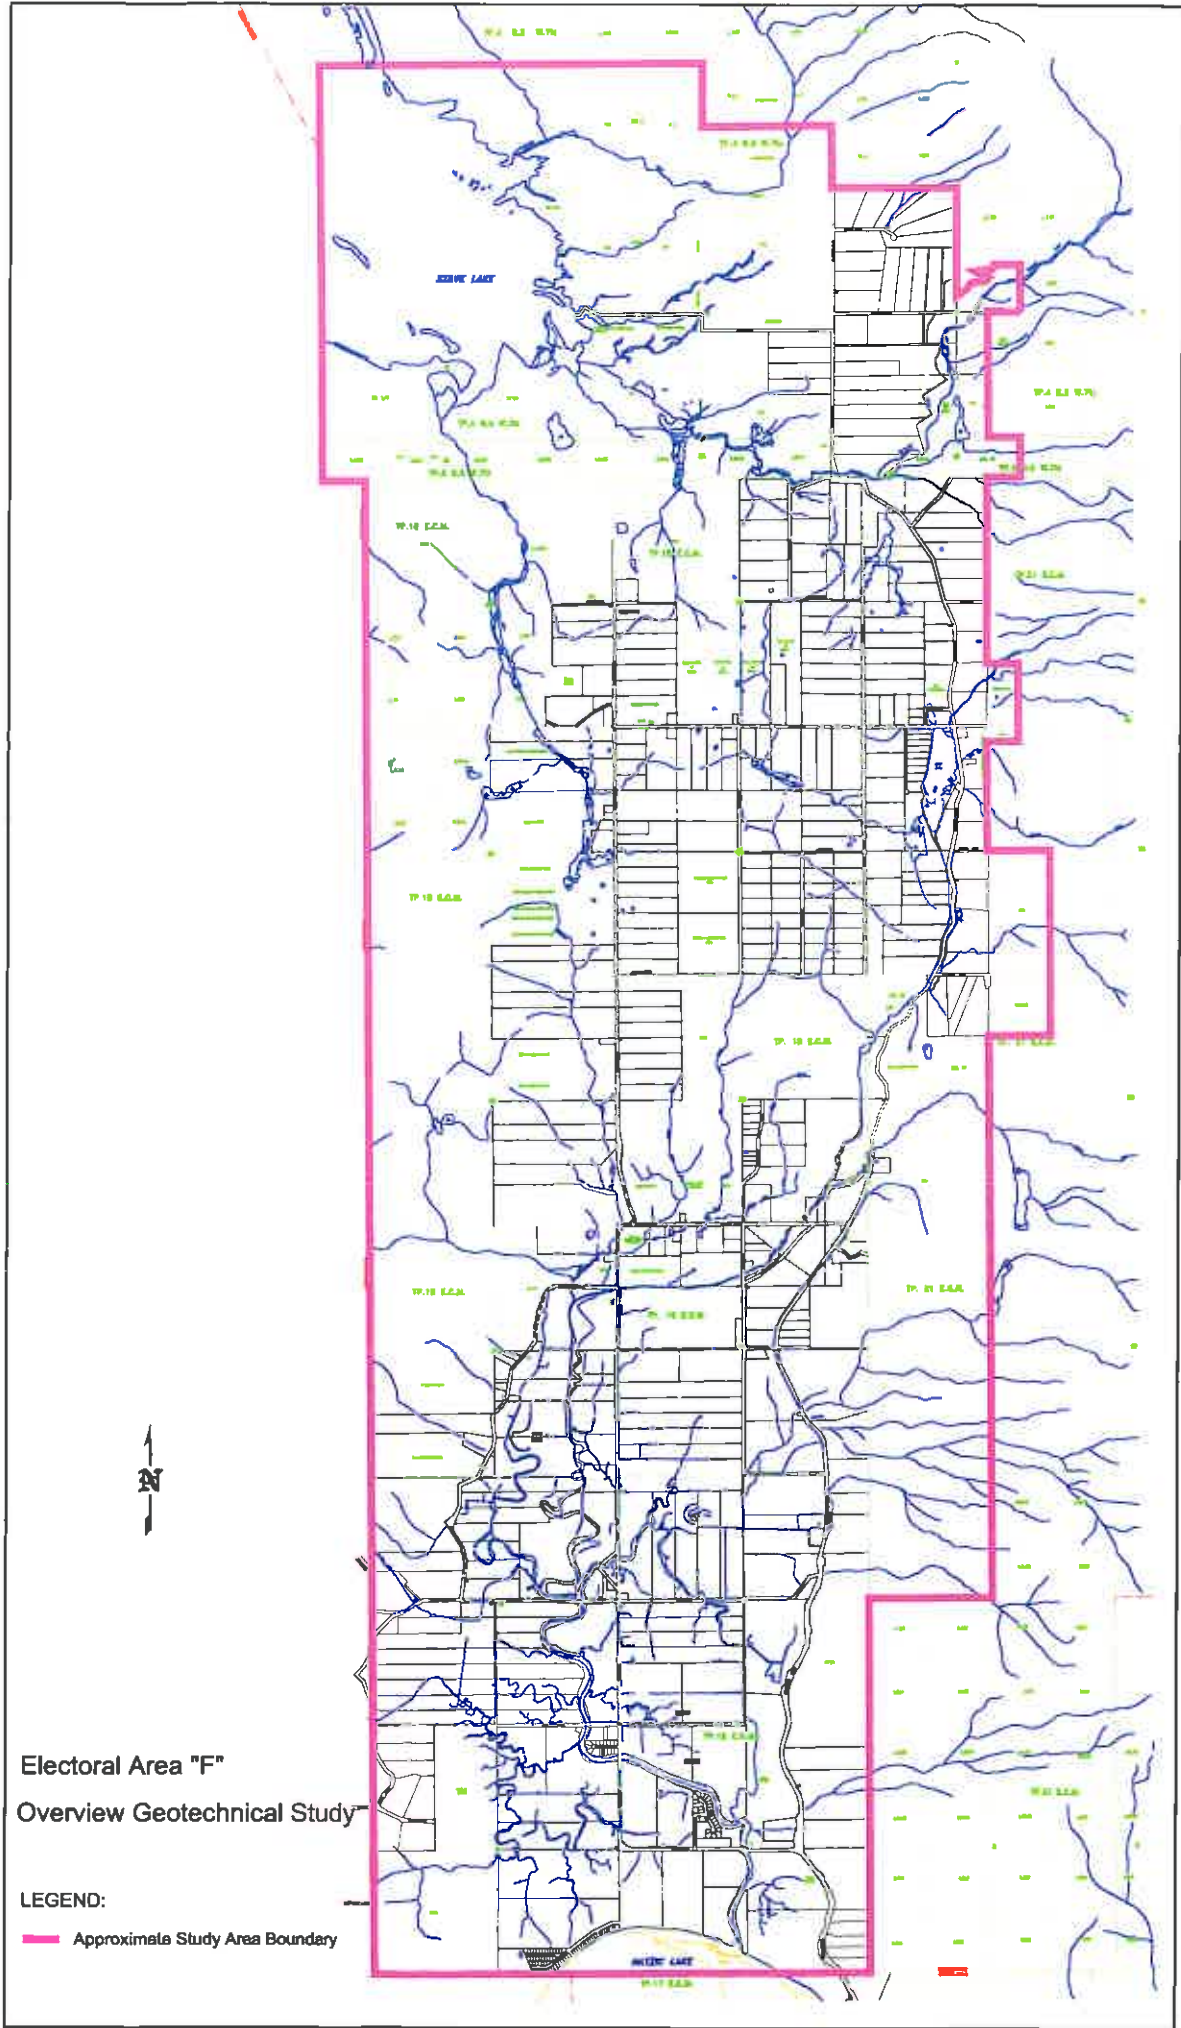
Figure 1

Five terrain complexes are defined on Figure 1² to facilitate Section 4 discussions. Each is formed by distinctive landform assemblages:

3.1 Bedrock-controlled Mountain Slopes (M on Figure 1)³
